➤ YAŞANABİLİR ŞEHİRLER SEMPOZYUMU, LIVABLE CITIES SYMPOSIUM

➤ Salvador Herrera
CTS EMBARQ Mexico Deputy Director

Metrobus Line 4 Connection to Historical District

Road safety audit process

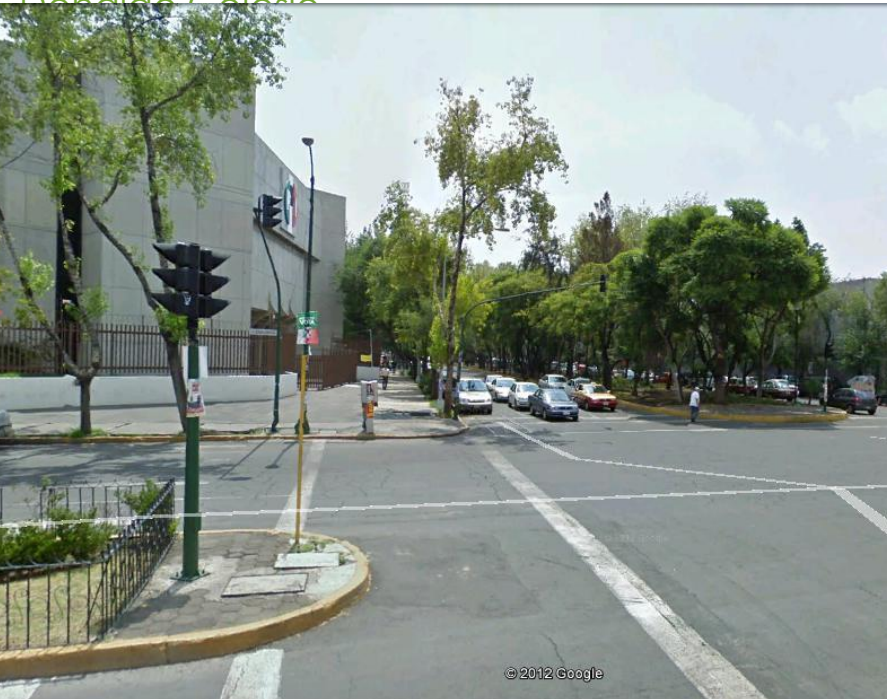
“4.5.1. Pedestrians waiting in the median are particularly vulnerable in case vehicles using the adjacent lanes accidentally run over the pedestrian refuge island.

The designers should also ensure that pedestrians waiting in [median refuge islands] are protected from traffic. This can usually be achieved by placing bollards along the edges of the islands [...] or other types of security devices [such as kerbs].”

Before (2011): Unprotected pedestrian refuge island at the corner of Jesus Garcia and Luis Donaldo Colosio

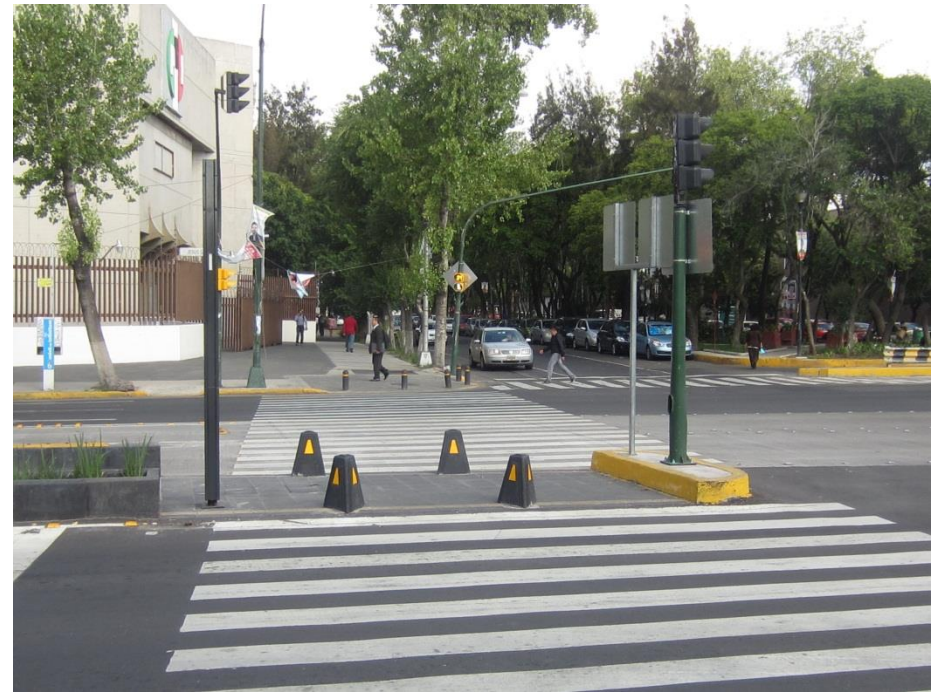
After (2012): Well protected island

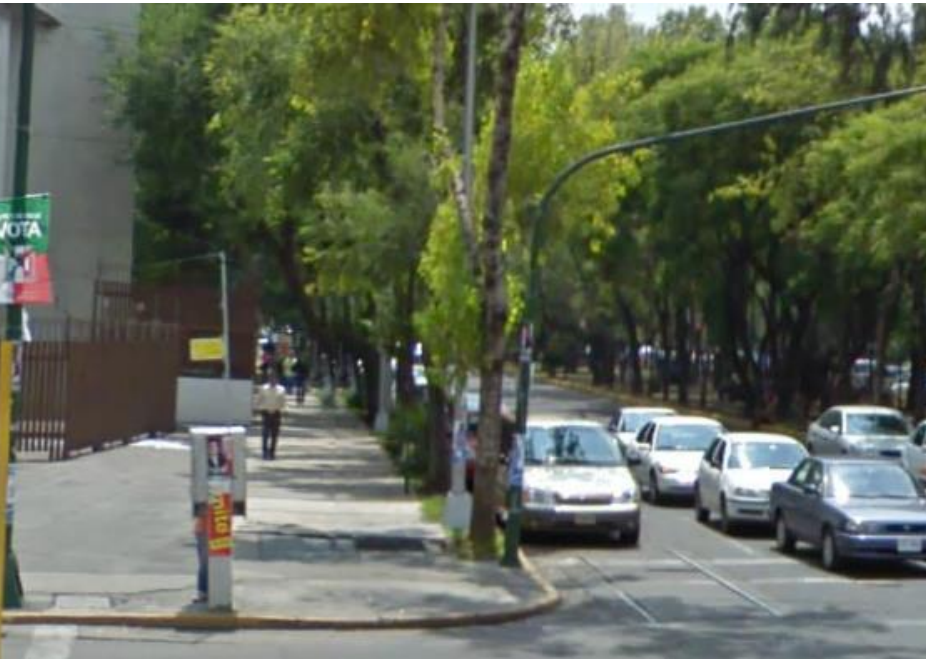
Before (2011): Signalized intersection without pedestrian signals (corner of Jesus Garcia and Luis Donaldo Colosio)

“4.4.1. It is recommended that pedestrian signals be installed in all signal-controlled junctions.

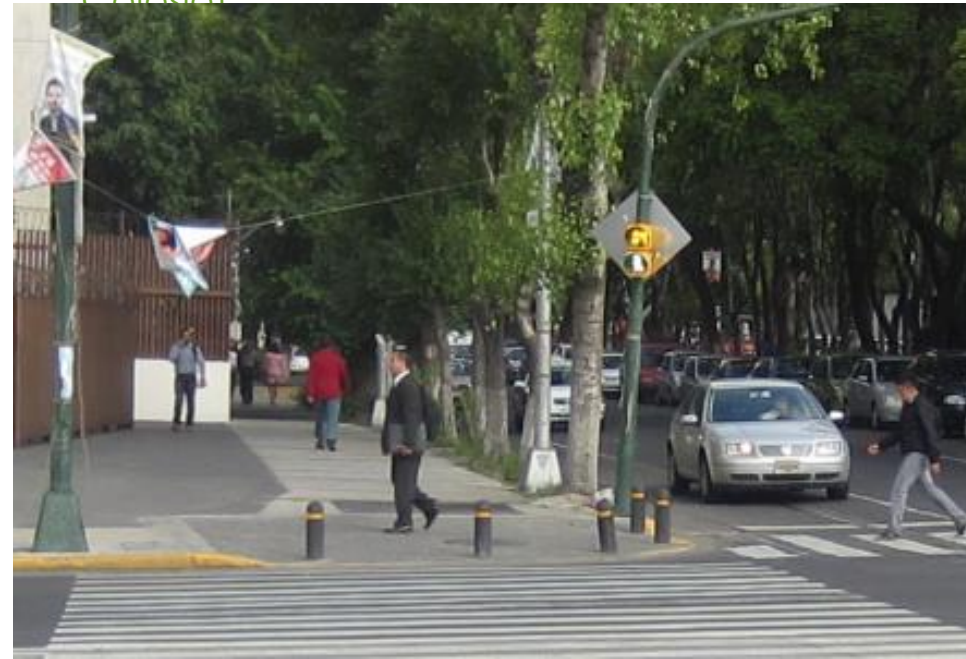
After (2012): New pedestrian signals installed at the corner of Jesus Garcia and Luis Donaldo Colosio)

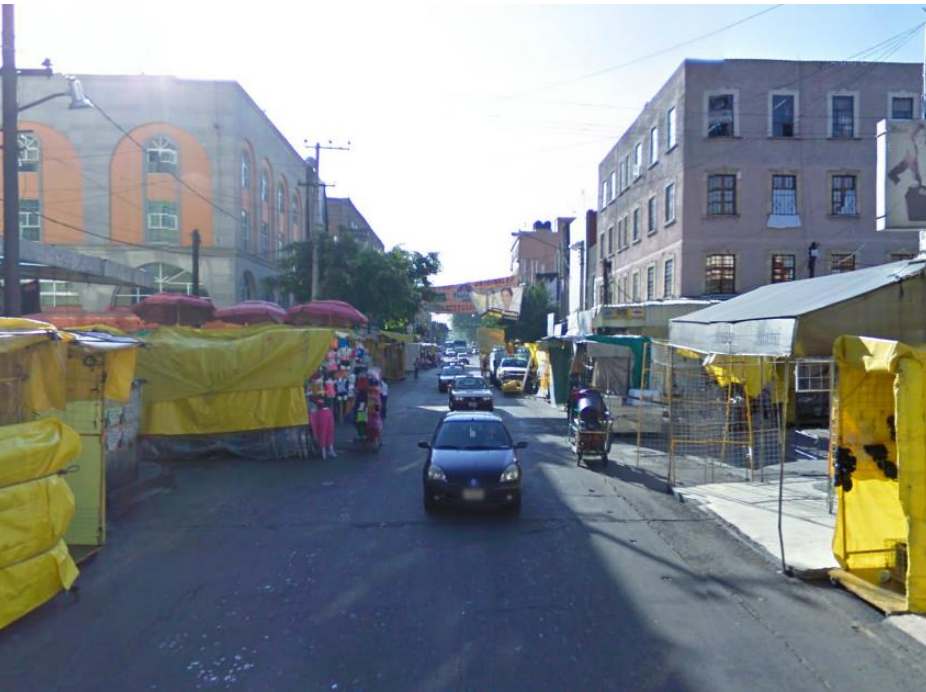
“5.64. This section features many informal vendors occupying the sidewalks, which may also result in pedestrians walking in the roadway [...] From a safety perspective, it is important to provide adequate space for pedestrians on the sidewalks, to ensure that they do not end up walking in the bus lanes.”

Before (2011): Sidewalks completely taken over by street vendors on General Miguel Aleman

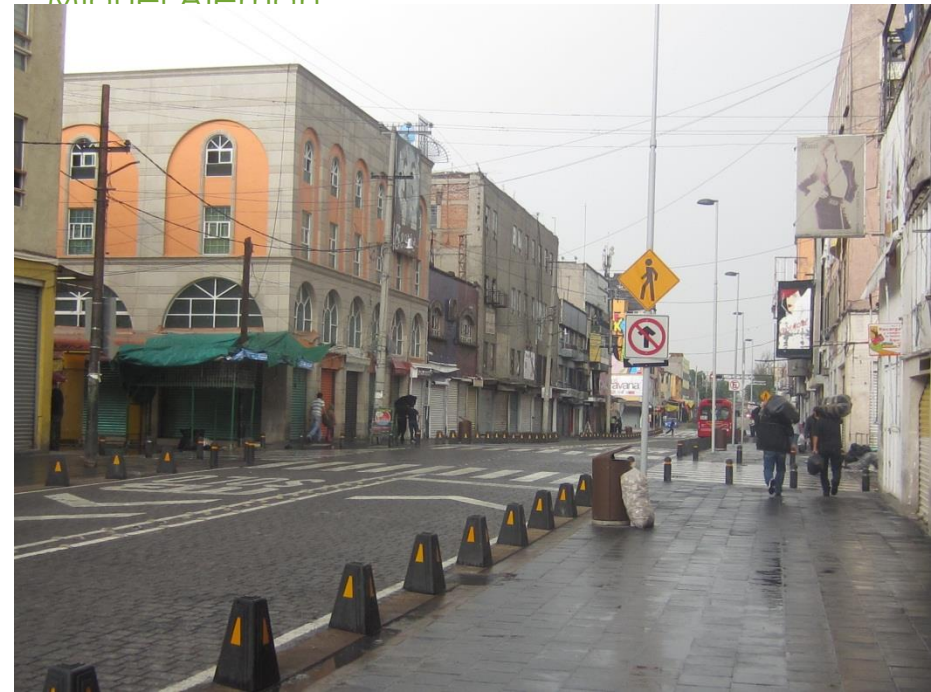
After (2012): 500 meters of sidewalks were recovered for pedestrian use on General Miguel Aleman

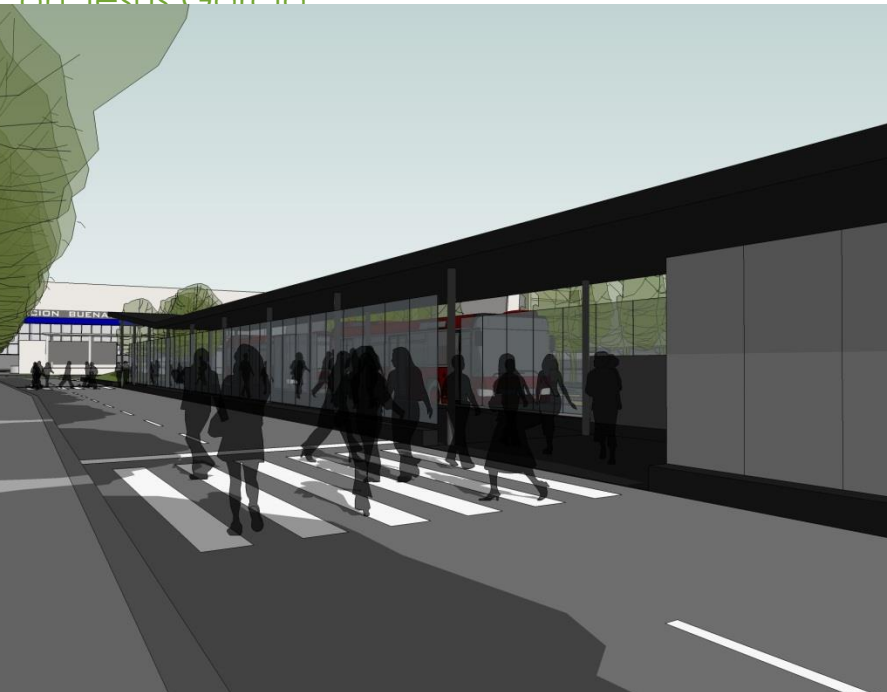
Before (2011): Rendering showing access to Terminal Buenavista across two lanes of traffic on Jesus Garcia

“5.1. Many passengers are expected to transfer [at Terminal Buenavista] to other Metrobus or Metro lines. This will create many conflicts [...] **It should be considered to close Jesus Garcia to vehicle traffic on this section.**”

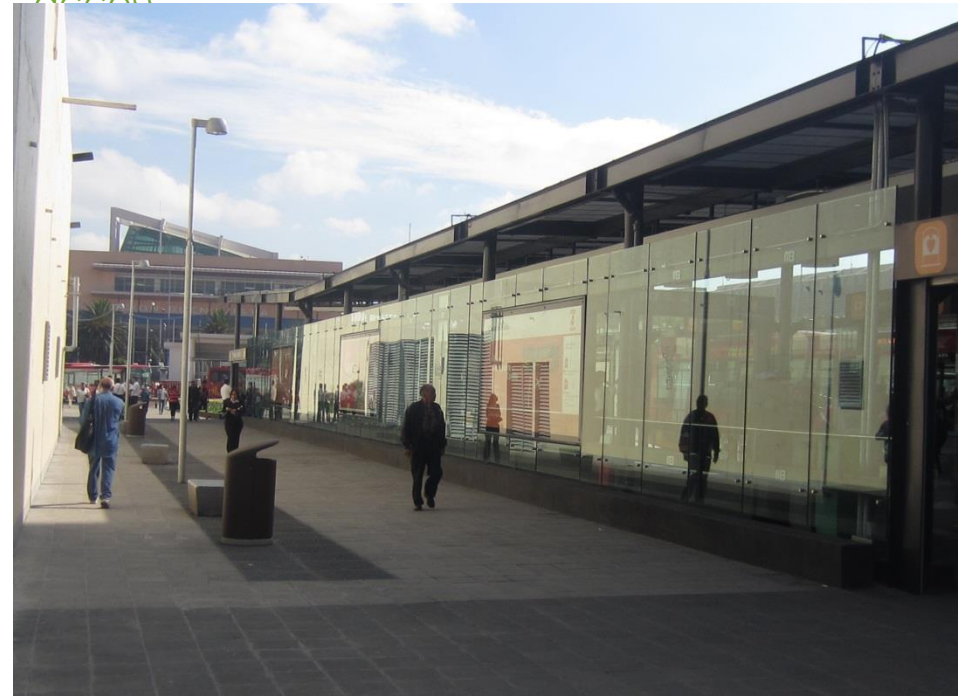
After (2012): Entrance to Terminal Buenavista from a pedestrian plaza, closed to vehicle access

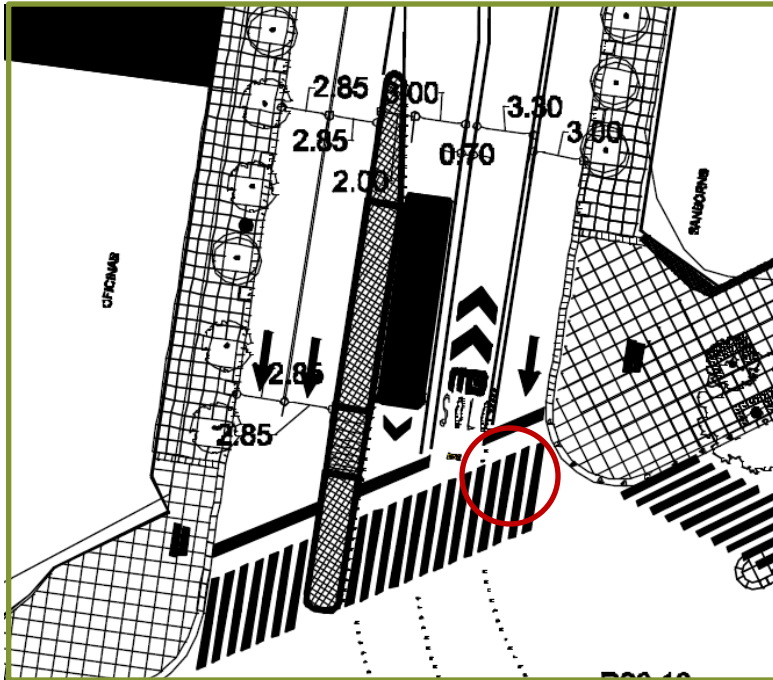
Before (2011): Project drawings showing a counterflow configuration on Lafragua

“5.6. In Lafragua between the circle and Reforma the design includes a counterflow lane for traffic from the circle. This is considered very unsafe especially because of the bus stop [...] The [counterflow] lane should be taken out.”

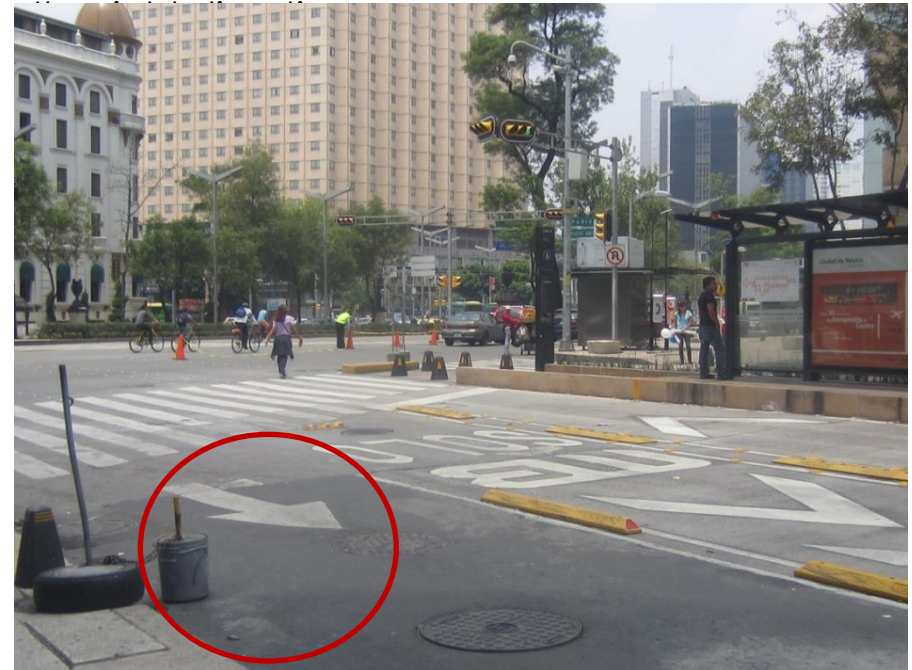
After (2012): The counterflow has been eliminated and the curbside lane now faces

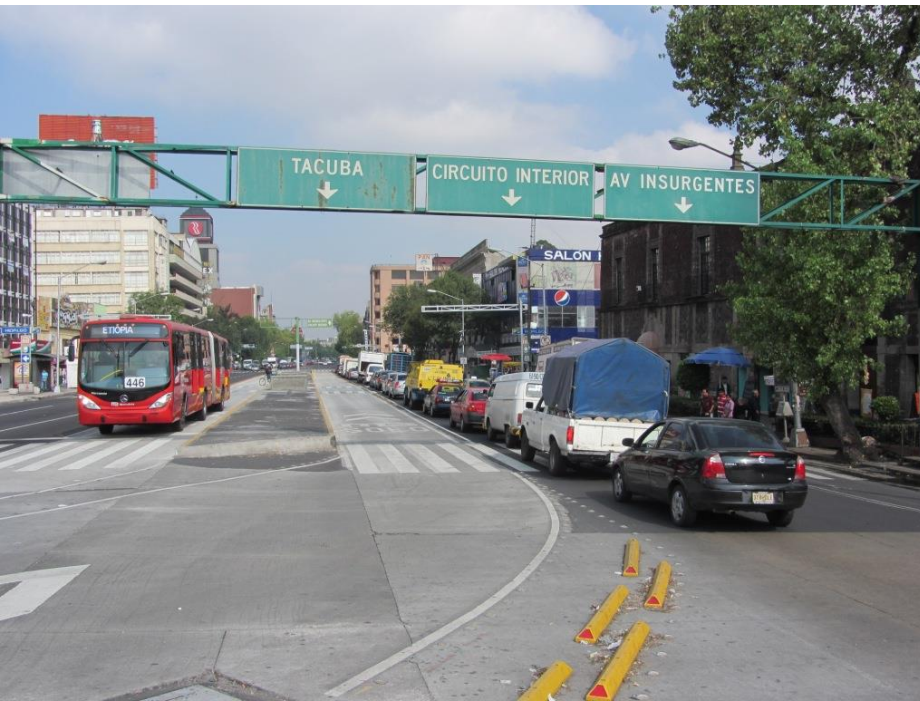
Before (2011): misleading traffic signs over bus lanes along Puente de Alvarado

“5.75. The sign indicating “Tacuba” should be removed from above the bus lane. [...]

“4.3.3. There should be clear and consistent signs and markings used for each type of lane (e.g. exclusive Metrobus lane)

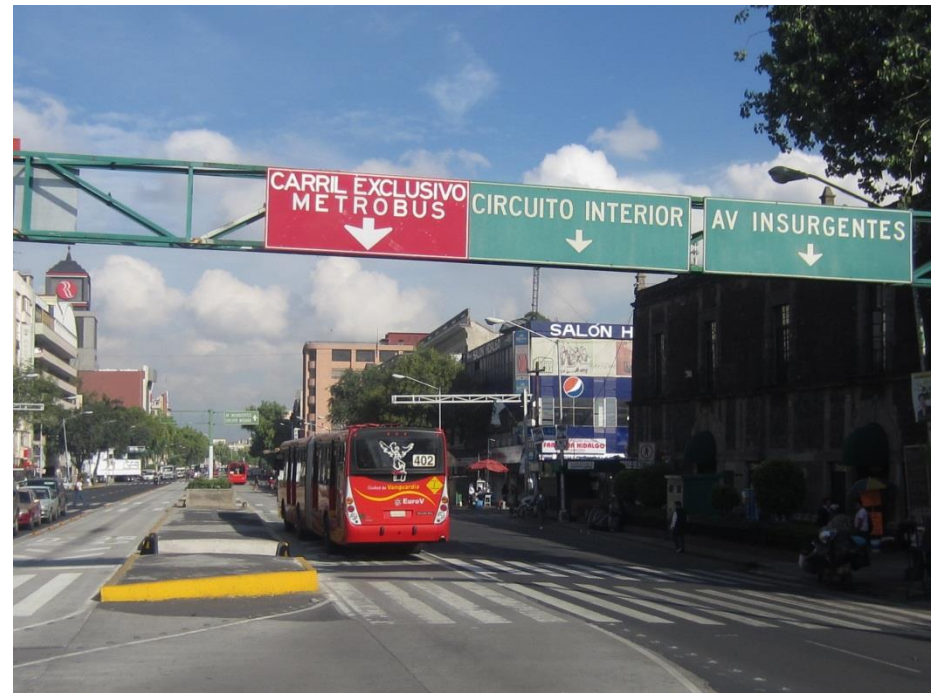
After (2012): Correct signs installed

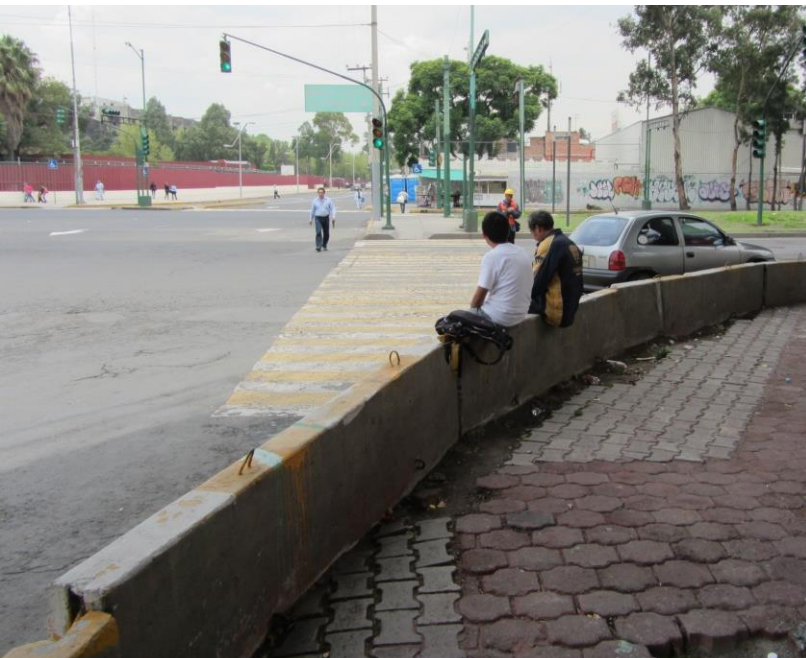
“5.55. The pedestrian crossing on the northern side [...] is not accessible at present.

Before (2011): Inaccessible pedestrian crossing along Eduardo Molina

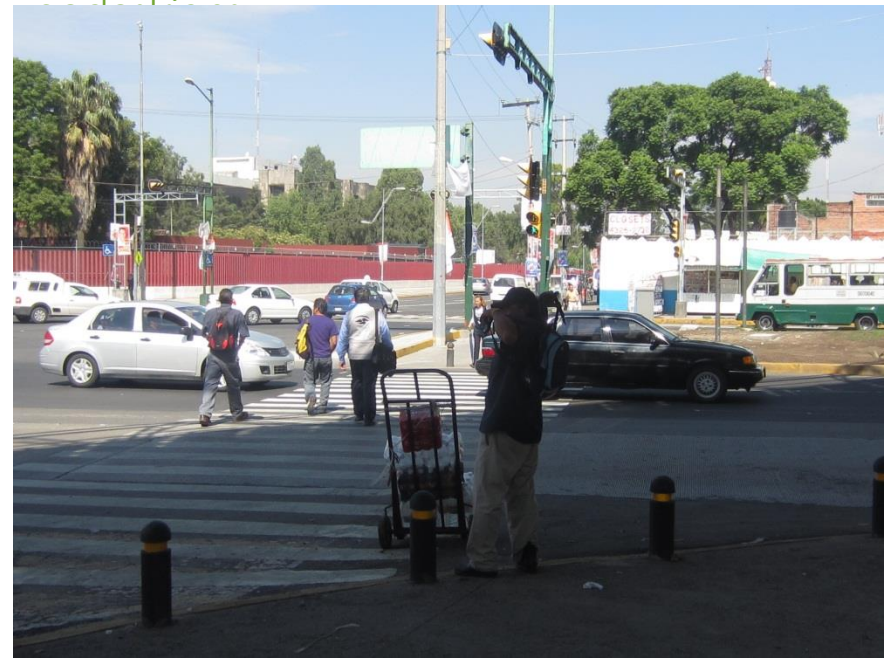
After (2012): Pedestrian access restored, along with bollards for protecting

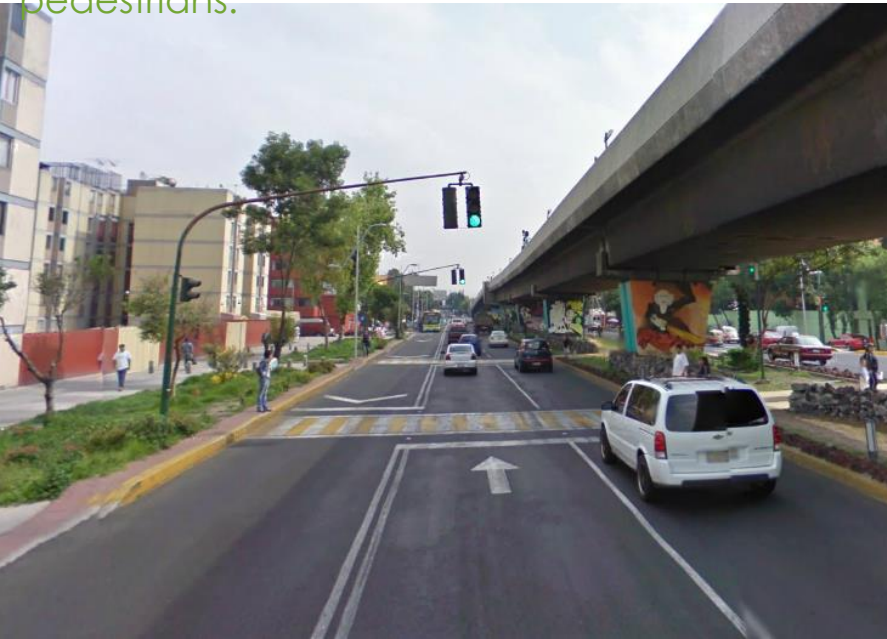
Before (2011): Signalized mid-block crossing on Eje 2 Oriente, with no traffic calming. Vehicles did not stop for pedestrians.

“5.53. The pedestrian crossing should be made a raised area or protected by a gentle [speed] hump. “

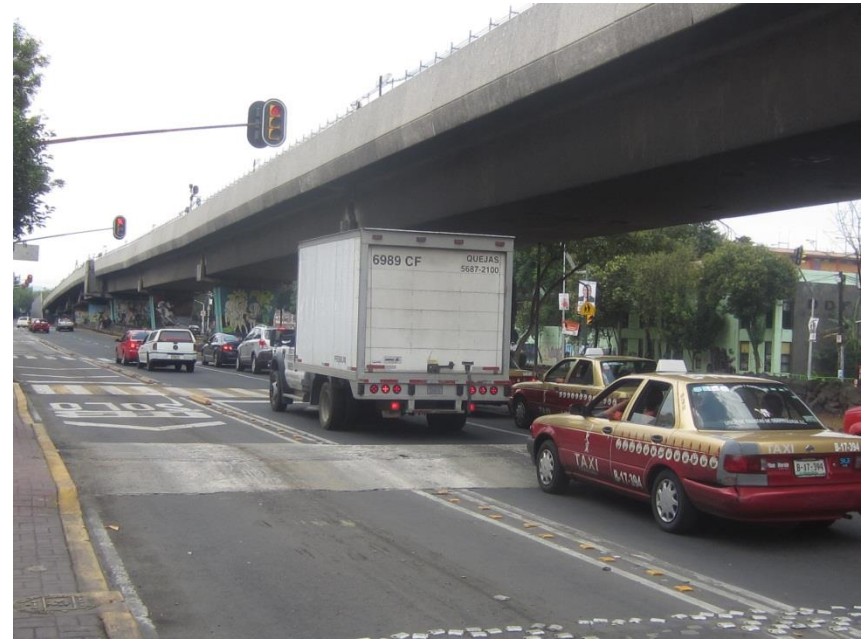
After (2012): Speed hump installed before the pedestrian crossing, slowing traffic down and allowing pedestrian to cross safely.

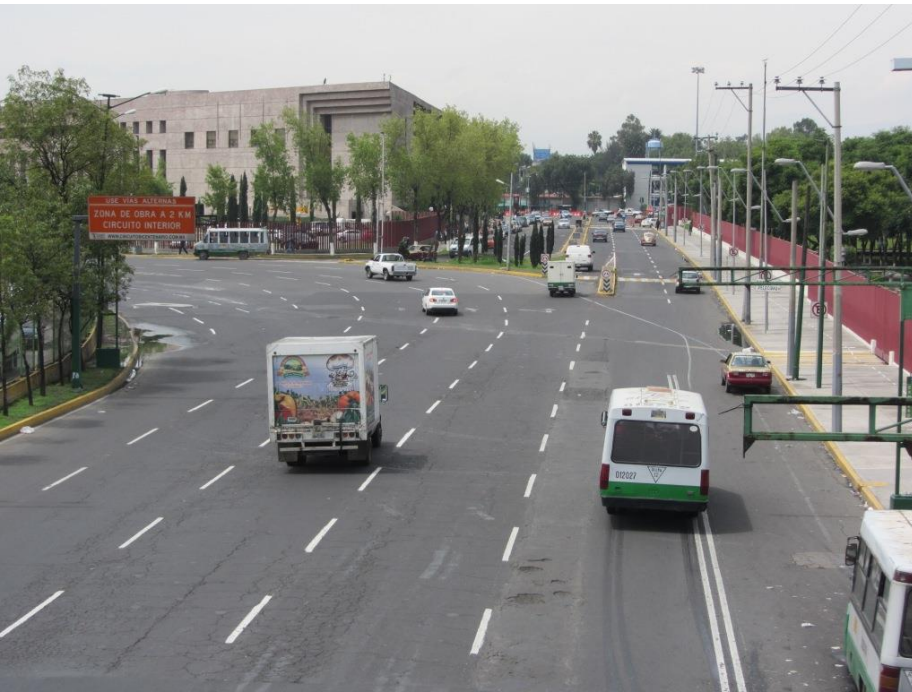
“5.52. [The street] is very wide here and the number of lanes and the width of the lanes vary. It was observed that many pedestrians cross here although there are no facilities for them. This is very unsafe because of the relative high speed of vehicles.”

Before (2011): Eje 3 Eduardo Molina. Very wide street with high vehicle speeds and frequent jaywalking. A major black spot.

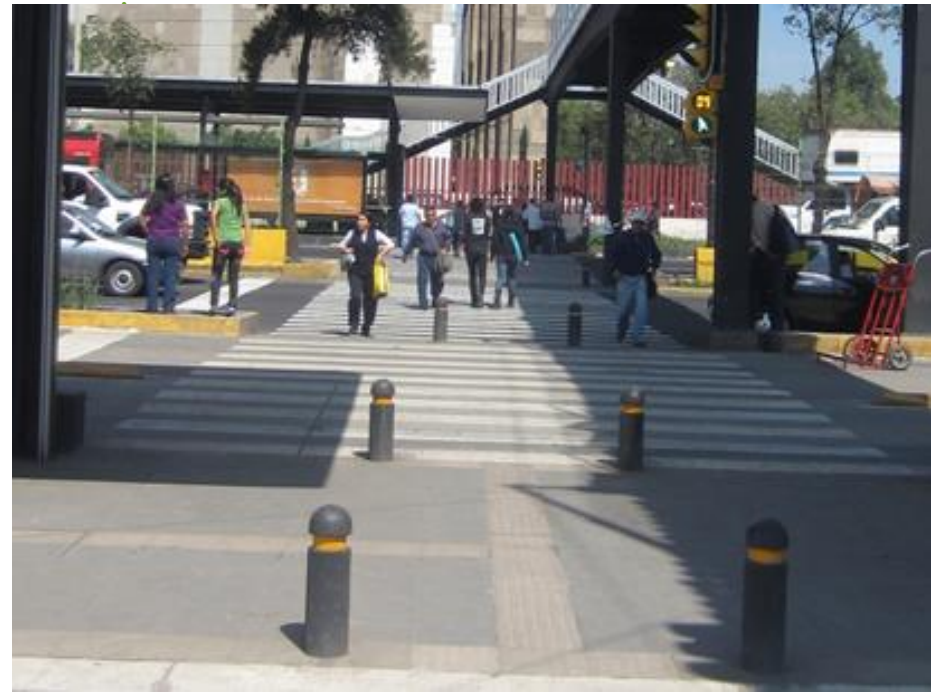
After (2012): Signalized pedestrian crossing installed, with protected pedestrian space and four refuge islands to break up the
